Restoration of Moizari River

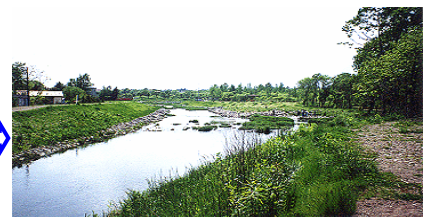
Before development

After development

Disaster-prevention construction created a shortcut stream leaving the riverbed or the old river course area, but it was developed into a channel so as to be ecologically connected to the mainstream. After reestablishing the water flow in the channel, previously non-observed kingfishers were frequently found catching small fish around the channel outlet. This is expectedly caused by growing number of fish thanks to exploding water insects which live in the bed of fallen broad-leaves such as alder, and to leafhopper, leaf beetle, and moth larva that fall from the trees to be eaten by small fish.

Chatteing channel and walking trail were developed along the remaining old river course to establish a comfortable river space. The soft administrative path (river-walk) paved with wood-chips is continuously utilized for welfare and education, such as morning or evening walking (senior citizens) and daytime running (students).
