Restoration of Skjern River (Denmark)

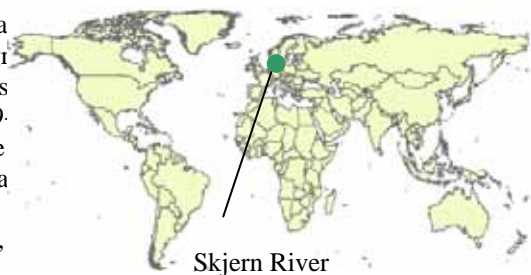
Skjern River, the largest river in Denmark, with 2500-km² catchment basin, flows into a fiord along the North Sea. The flood fields used to be utilized as natural meadows rich with grass thanks to azote and phosphorous provided by floods. In 1960s the winding 29-meter course was changed to a straightened 19-meter course. Banks were created and drainage facilities were prepared in order to lower the underground water level in the flood fields, and an area of 4000 ha was drained. After these changes, serious problems were found, including loss of loess, sunken farmlands, and downstream fiord contaminated with sediment and nutrient salts flowing from farmlands.
