# Reference Guideline for Restoration by Eco-Compatible Approach in River Basin ver.1

Separate Volume

Asian River Restoration Network

This separate volume was prepared as a supporting material of the "Reference Guideline for Restoration by Eco-Compatible Approach in River Basin ver.1" published in March 2009.

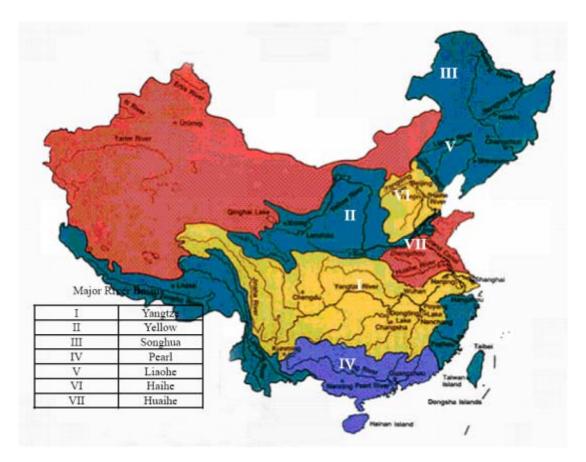
Table1
 Date of Seven Major Rivers in Chana

The main river systems in China consist of seven major rivers: The Yangtze, Yellow, Songhua, Pearl, Liaohe, Haihe and Huaihe rivers.

River	River Length (Km)	Basin Area (10 <sup>3</sup> km <sup>2</sup> )	Average Annual Runoff (Km <sup>3</sup> )	
Yangtze	6,300	1808.5	975.7	
Yellow	5,464	752.4	59.2	
Songhua	2,308	557.2 453.7	74.2	
Pearl	2,214		336.0	
Liaohe	1,390	229.0	14.8	
Haihe	1,090	263.6	22.8	
Huaihe	1,000	269.3	61.1

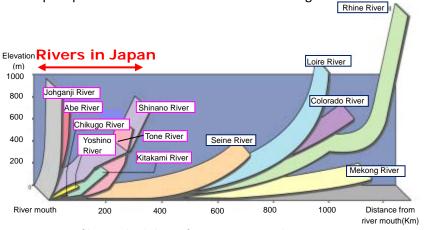
Comparison of longitudinal slope of rivers in Japan and main rivers in overseas

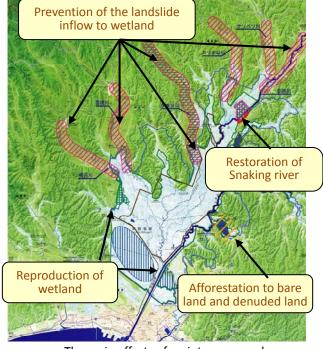
The main efforts of maintenance and reproduction of Kushiro wetland

•This nature restoration project is targeting the previous wetland environment, which was before registered as Ramsar site and started rapid deterioration. In order to prevent landslide inflow to the wetlands, wide-ranging efforts over the entire wetland, i.e. restoration of the snaking river, afforesting the bare land and denuded land, and maintenance and restoration of the wetland, has been conducted.

natural reproduction conference, protection and rebirth of marshland, and restorations of meandering stream

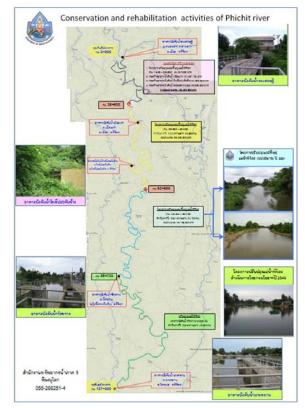
#### X-section of dredging

- In the fiscal year 2003, 2008, Phichit river project previous stage and stage I : To excavate and channel improvement of Phichit river for 75 km. and Bang Klan, Wat Kwang and Dong Settee control structures at the amount of 232 million baht.
- In the fiscal year 2009, Phichit river project stage II : To excavate and channel improvement of Phichit river for 22 km. at the amount of 34 million baht.
- In the fiscal year 2010, Phichit river project stage III : To excavate and channel improvement of Phichit river for 27 km. at the amount of 60 million baht.

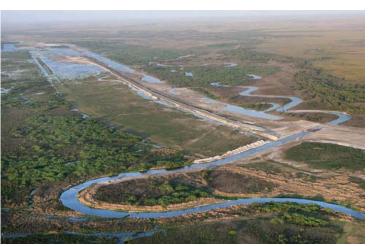
New meandering Kissimmee River (ORLANDO SENTINEL / December 22, 2009)

• In the lower basin, approximately 22 miles of the Canal will be backfilled. Also excavating nearly nine miles of river channel, and removing two water control structures and locks.

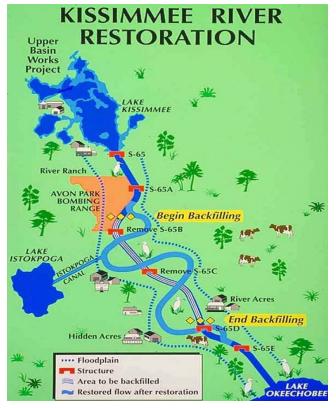
Kissimmee River Restoration Project (C-37 Canal Widening Public Meeting (November 19, 2009), US Army Corps of Engineers)

• The project developed a comprehensive evaluation programme named 'Kissimmee River Restoration Evaluation Programme'. It takes performance measures to predict ecological changes that are expected to result from the project, including changes in hydrology, water quality, and major biological communities such as plants, invertebrates, fish, and birds.

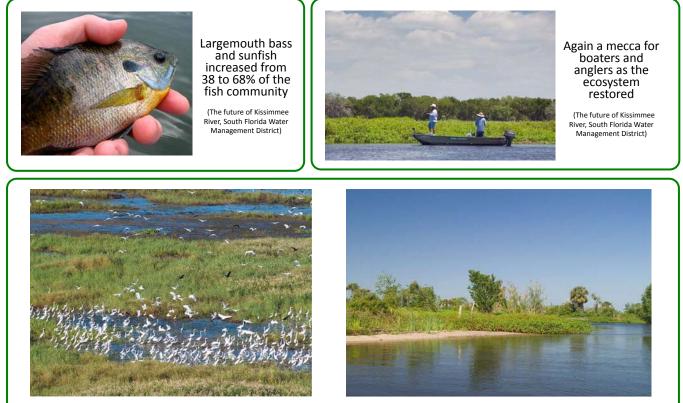
New habitat is created by the Restoration (The future of Kissimmee River, South Florida Water )Management District)

•The comprehensive continued monitoring documented promising increases in dissolved oxygen levels, reductions in river channel floating plant cover and accumulated sediments on the river bottom, recovery of wetlands, and increased populations of waterfowl, wading birds, and bass and other sunfishes.
