Sumida River, JAPAN

Akira WADA
Japan River Restoration Network

**Panel on Urban Water/River Front Redevelopment
World Bank Tokyo Office –May 30th, 2011**

The Sumida River - Representative River in Tokyo

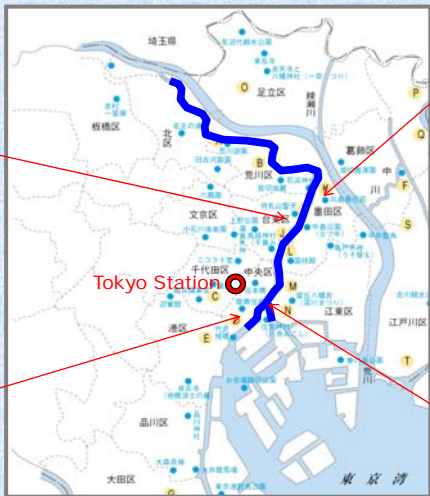
River Length: 23.5km, Area: 690km², Population: 3 milli.
Operating Body: Tokyo Metropolitan Government
The entire river is a tidal river, which is influenced by tides.

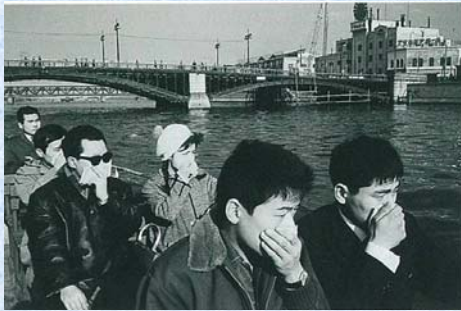
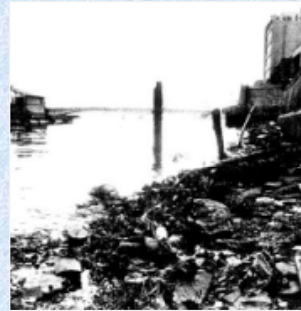
1967

Due to an increase in population and factories along the river, the water quality deteriorated. In particular, in the period of high economic growth (1950 to 1960s), BOD reached 40mg/l, the deterioration of the river environment reached a peak, and a bad smell drifted into surrounding areas.

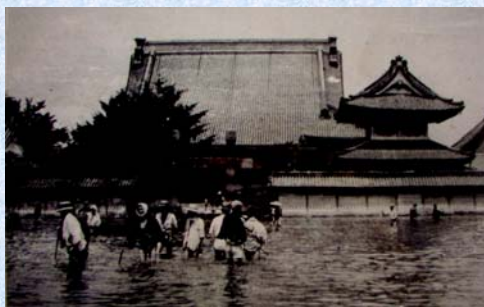
1910, Sensoji Temple

Floods hit lowlands frequently in 1900s.

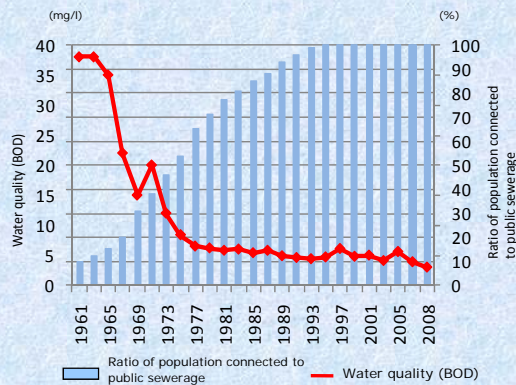
Various measures were taken to improve water quality. For example, a sewage system was reconstructed in the basin (diffusion rate increased from 10% in 1961 to 100% in 1995); regulations on plant effluent were tightened; and water was drawn from the Tone River to purify river water.

- Construction of sewers
- Waste water regulation against factories
- Removal of polluted mud by dredging
- Water transmission from the Tone River
