Channel Response Prediction for Abandoned Channel Restoration and Applicability Analysis

ARRN Forum 2013

10th International Forum on Waterfront and Watershed Restoration

Yonguk RYU, Il HONG, Joon Gu KANG, Hong Koo YEO

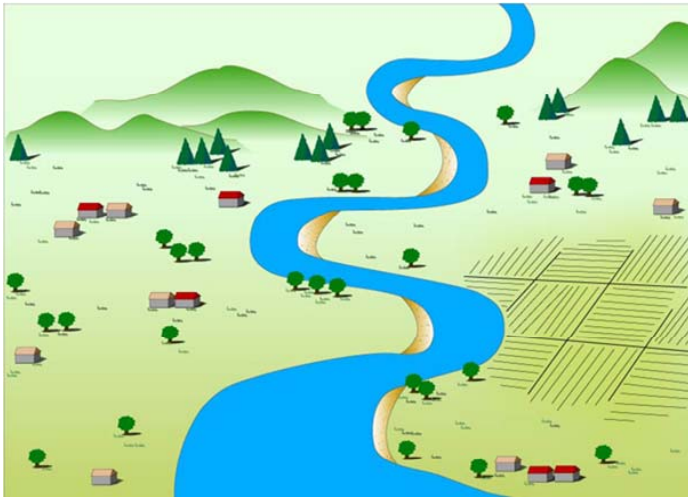
Schematic drawing of a natural river

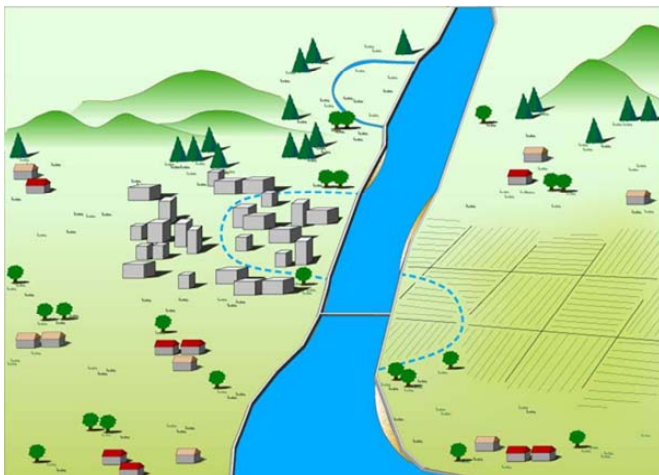
Channel straightening

- Artificial maintenance brought about many problems, such as decreasing floodplain and disturbed ecosystem.
- Channel straightening caused geomorphological problems, such as the decreasing of meander rivers and the formation of abandoned channels.

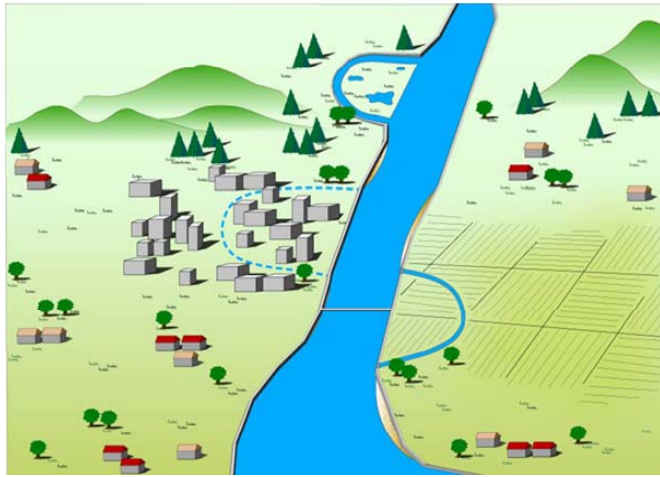
Abandoned channel restoration

- Abandoned channel restoration is one of the projects related to river restoration.
- This study targets past channels disconnected from main channels.

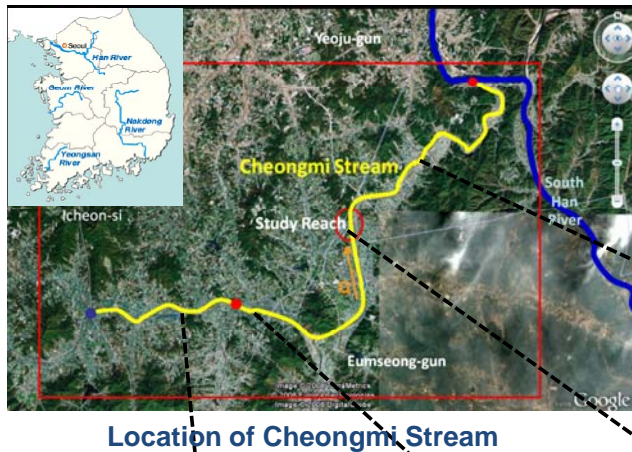
- The Cheongmi Stream is 60 km long and is located in the middle of South Han River.
- The abandoned channels of Cheongmi stream are AC-1 to AC-20 sites.
- **AC-17 site has been decided for the current project site after considering its feasibility.**

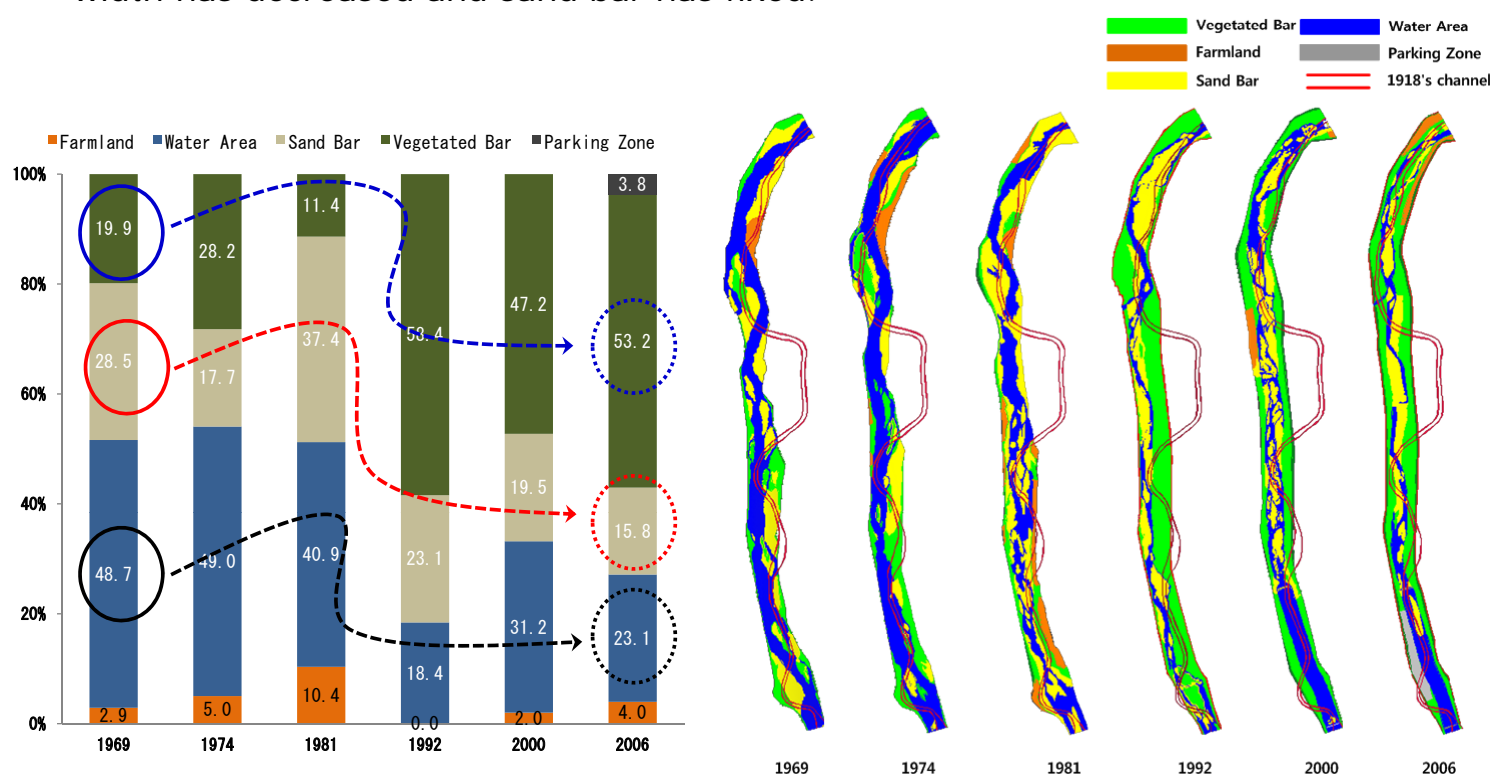
Change of Micro-landform in Channel

- We can see that the vegetation on bars has grown as the flow width has decreased and sand bar has fixed.

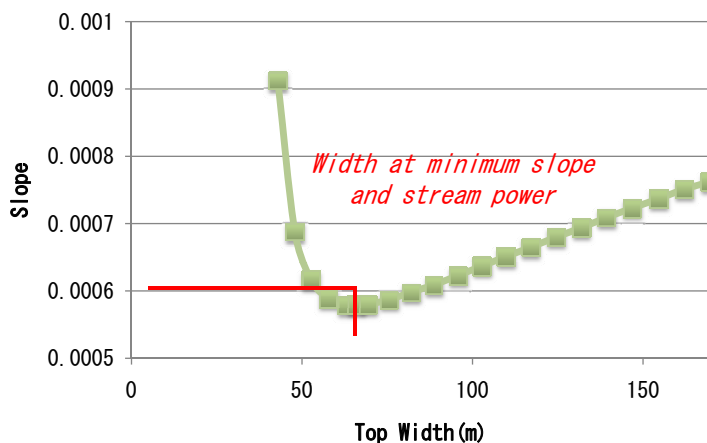
- The width of stable channel : 40 m ~ 160 m
- The depth of stable channel : 2.1 m ~ 7.6 m
- The slope of stable channel : 0.0007 ~ 0.0009
- These points are suitable for stable channel condition.

Stable channel slope and width from SAM

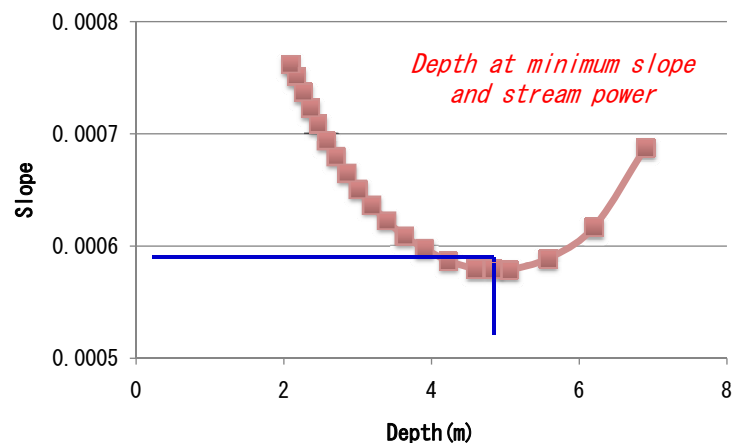
Stable channel slope and depth from SAM
